Technical Report M9

**ENVIRONMENTAL AND NAVIGATION IMPROVEMENT  
STUDY OF WOLF ISLAND  
MISSISSIPPI RIVER  
MILES 936.5 TO 929**

Prepared For  
U.S. Army Corps of Engineers  
Mississippi River Valley Division  
&  
Memphis District

June 2000

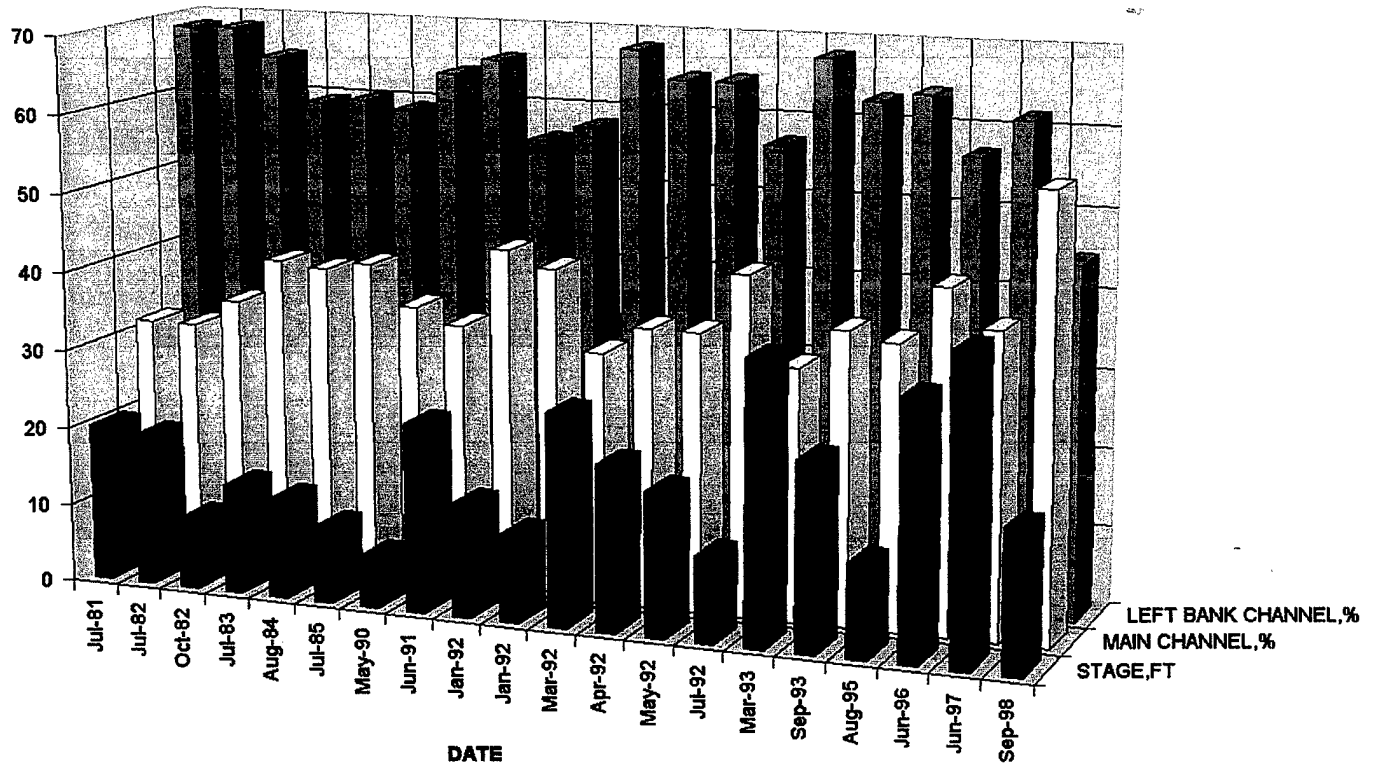
2

# WOLF ISLAND, MILE 933

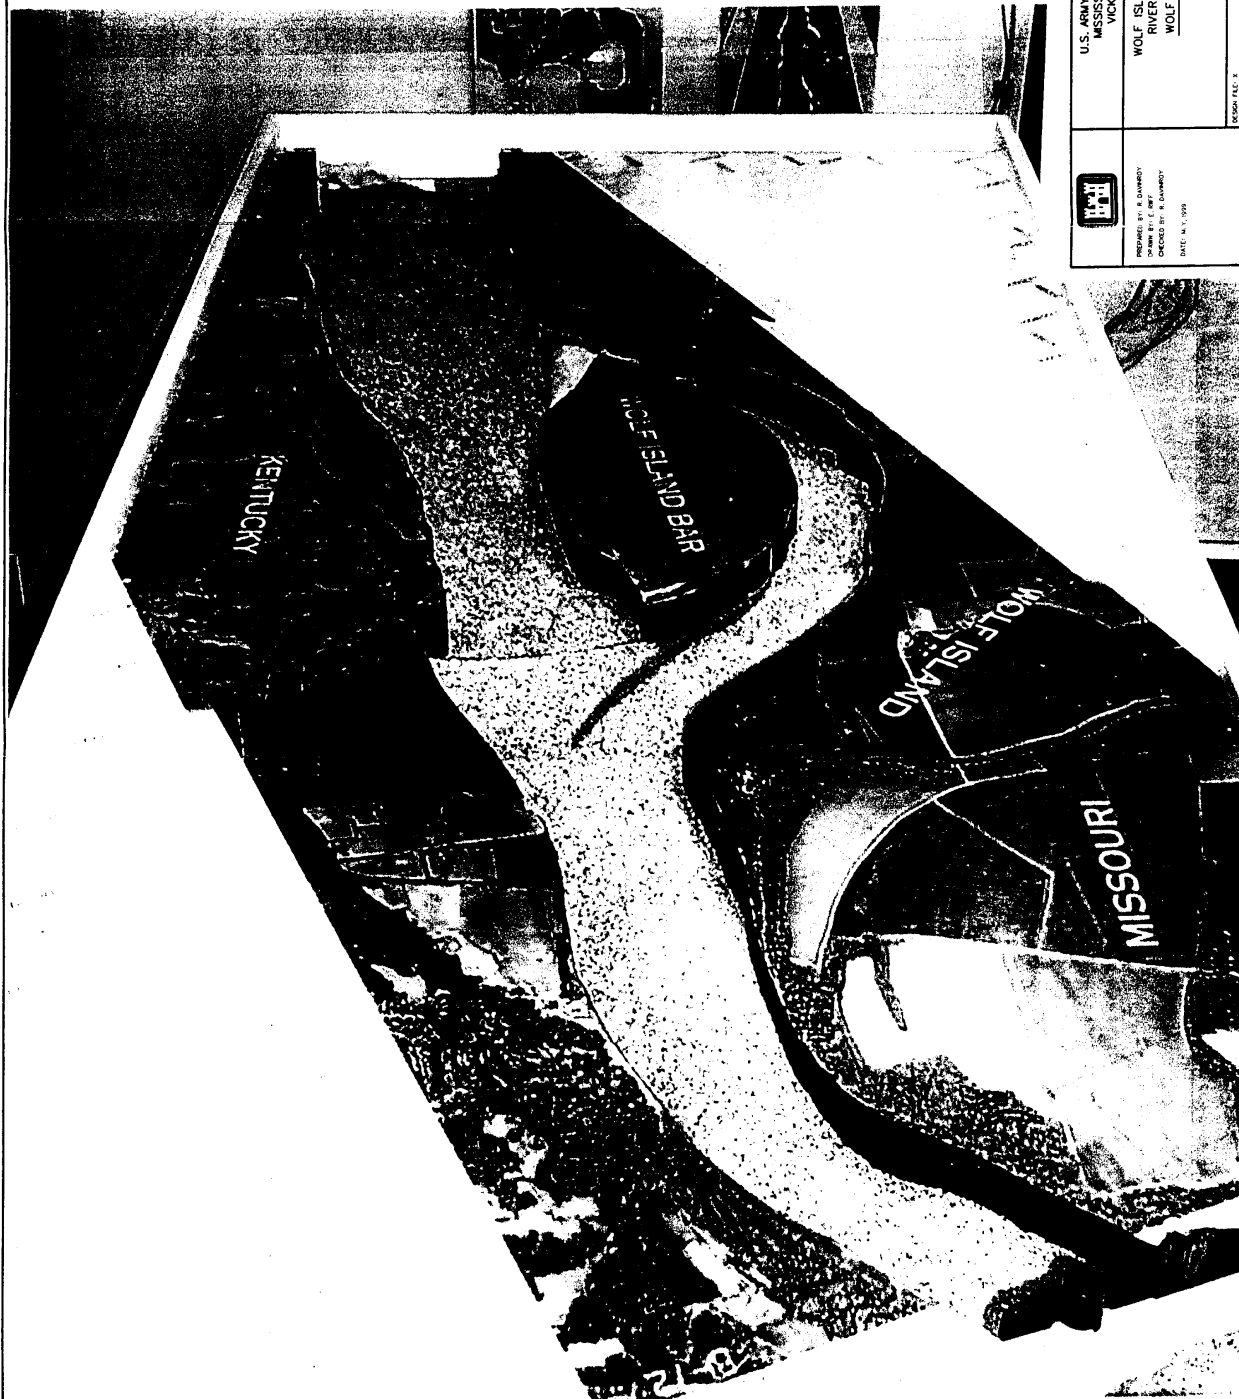
U.S. ARMY CORPS OF ENGINEERS MISSISSIPPI VALLEY DIVISION VICKSBURG, MISSISSIPPI	
	WOLF ISLAND MICRO MODEL STUDY RIVER MILES 936 TO 929.5 WOLF ISLAND MICRO MODEL	
PREPARED BY: R. DAVENPORT DRAWN BY: E. DUFF CHECKED BY: R. DAVENPORT DATE: 11/1/55	DESIGN FILE: 8	PLATE NO. 8
NOT SCALE		NOT DATE: 8

Plate 8 is a photograph of the Wolf Island hydraulic micro model used in this study. The scales were 1 inch = 600 feet, or 1:7200 horizontal, 1 inch = 50 feet, or 1:600 vertically, for a 12:1 distortion ratio. This distortion supplied the necessary forces required for the simulation of sediment transport conditions similar to the prototype. The bed material was granular plastic urea, Type II, with a specific gravity of 1.23.

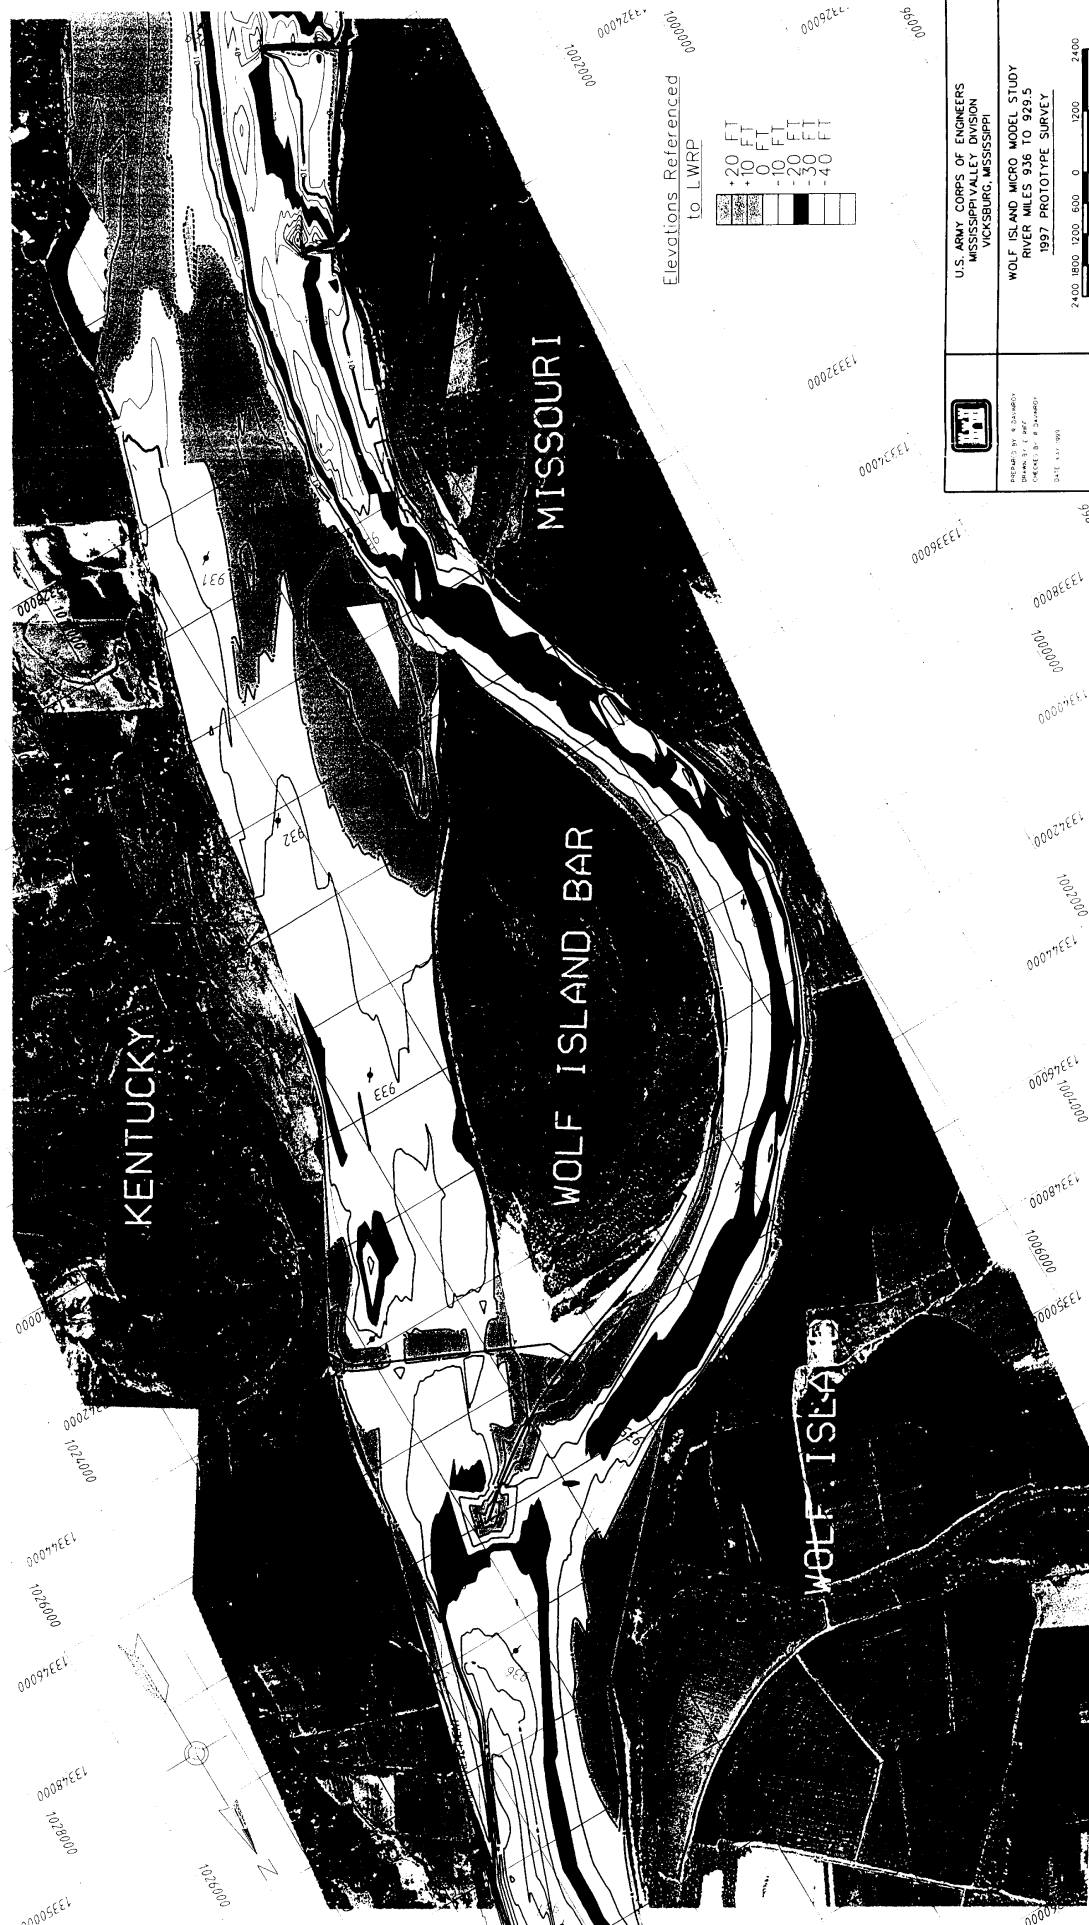
PLATE NO. 11

Several prototype surveys (1993/94, 1996, 1997, and 1998) were used to determine the general bed characteristics that have existed in the prototype over the years (Plates 9 through 14). Generally, only slight trend change differences were observed between the surveys from pre and post construction of the closing structure and longitudinal dike at the upper end of Wolf Island Chute. In the earliest 1993/94 survey, taken prior to construction, the bathymetric trends

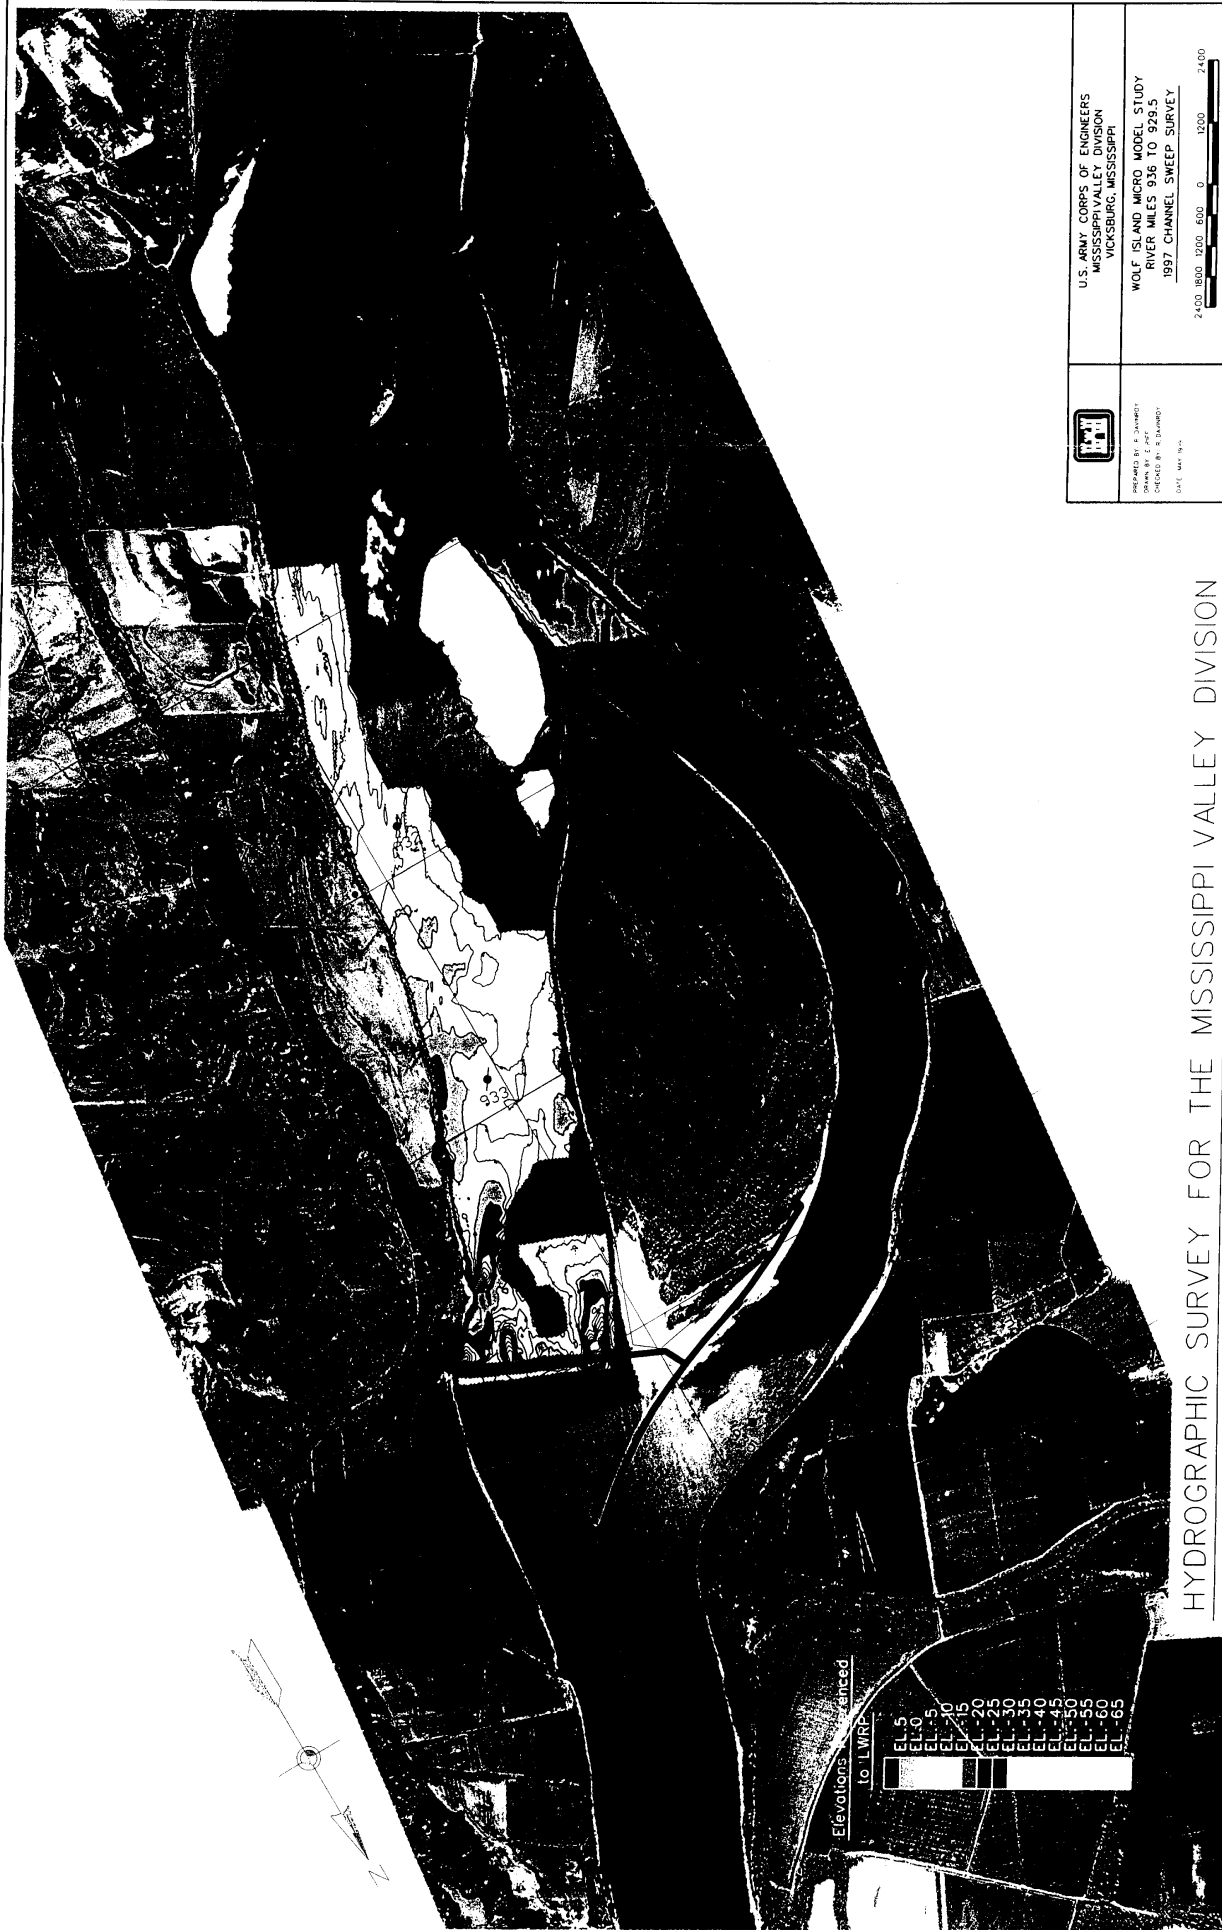
observed within both the main channel and the side channel were very similar to later post construction surveys. With the exception of the development of the localized scour holes formed downstream of the two notches in the closure structure and some slight deepening trends observed within the main channel, the trends were very similar.

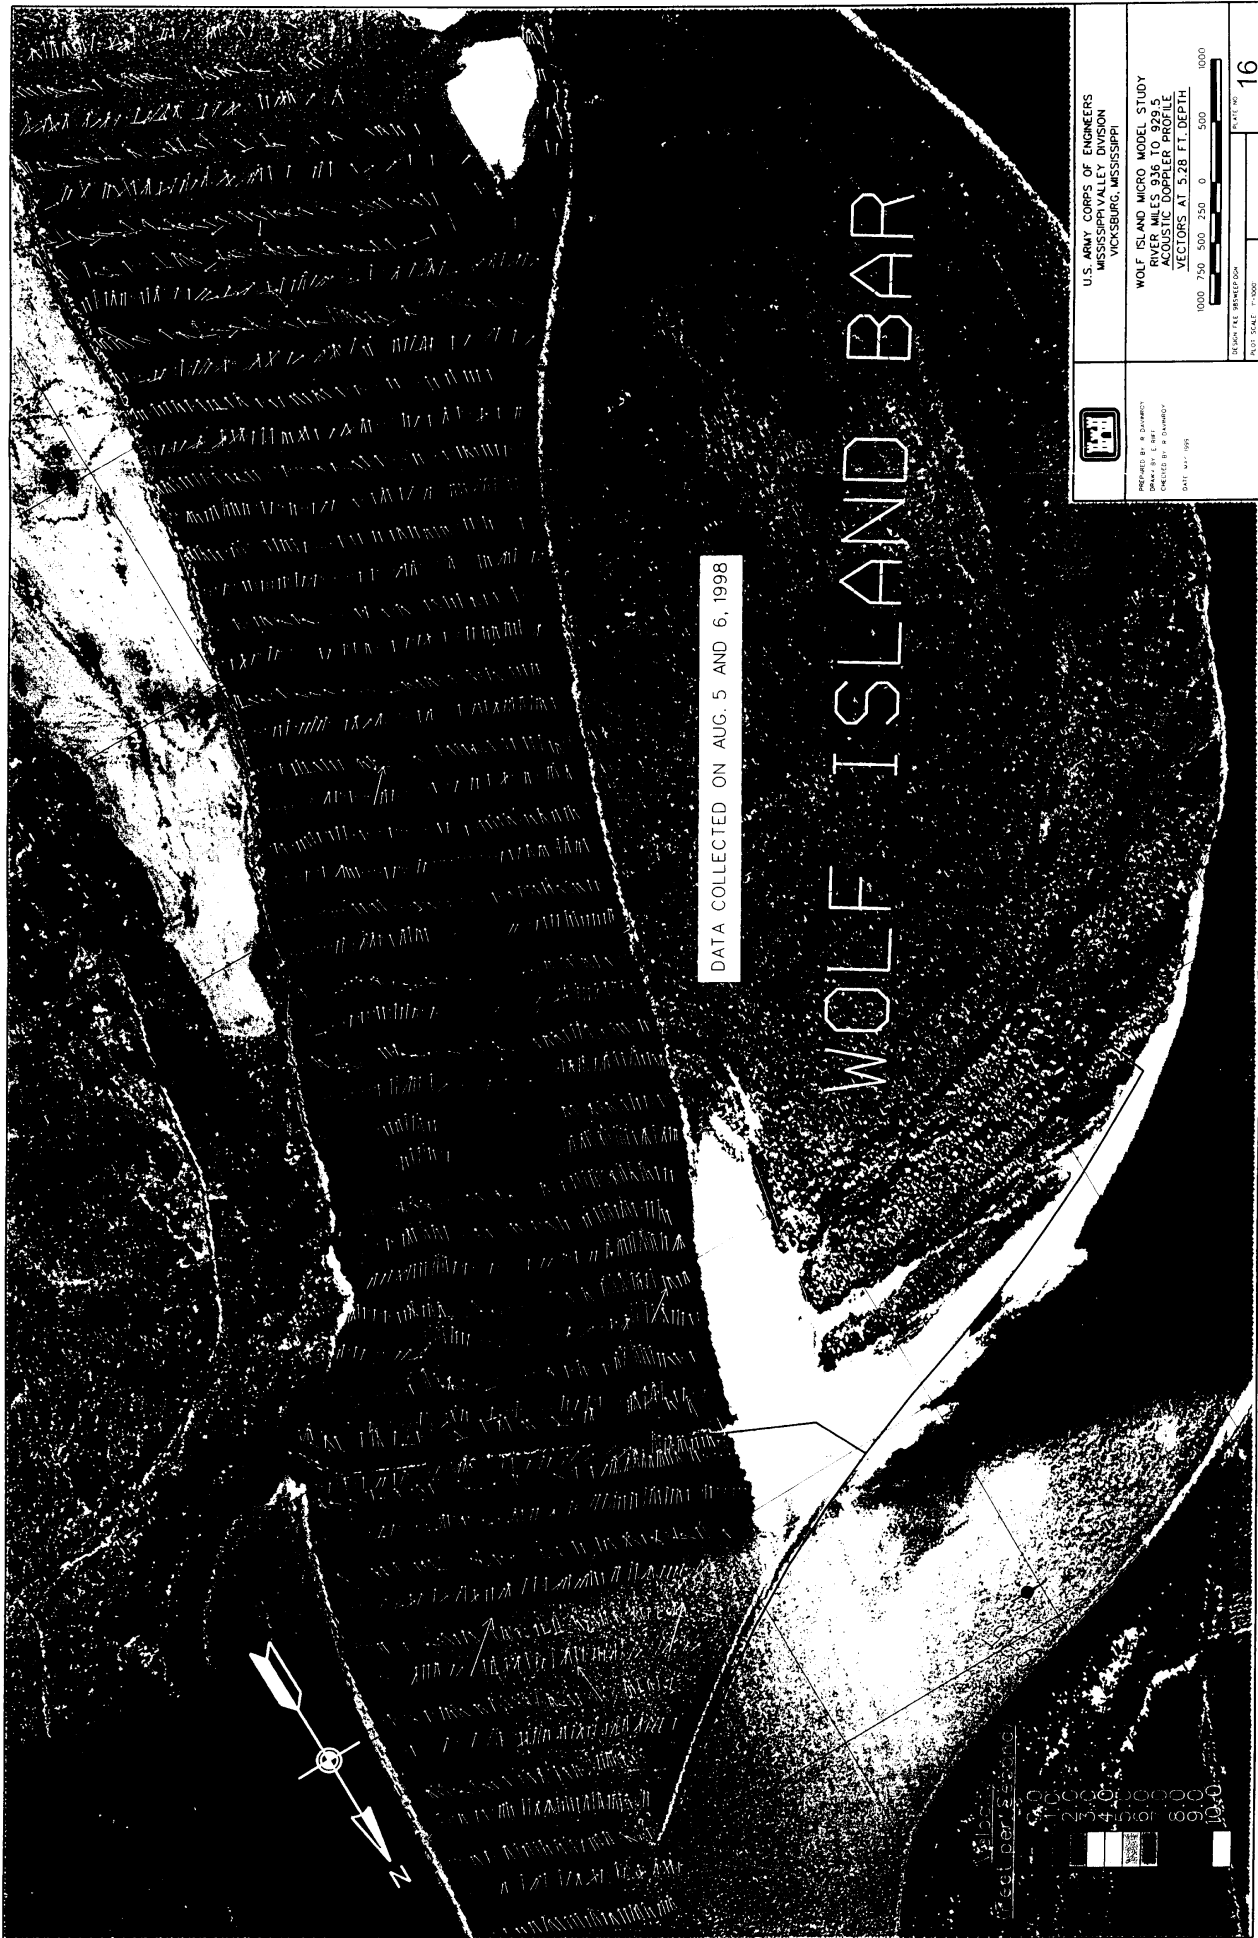
Plates 15 and 16 are plan view velocity vectors maps generated from Acoustic Doppler Current Profile (ADCP) data, obtained in the Mississippi River in 1996 and 1998, respectfully. Velocity data was extracted from profile information and plotted as plan view directional vectors at a depth of 5.28 feet. Results indicated the following:

In 1998, velocities were generally similar through both the right and left notches. Associated flow through the side channel seemed to be evenly distributed down the two channels below the notches. Near Mile 932, there was a considerable

amount of erroneous data that did not clearly define the proper direction of the velocities.

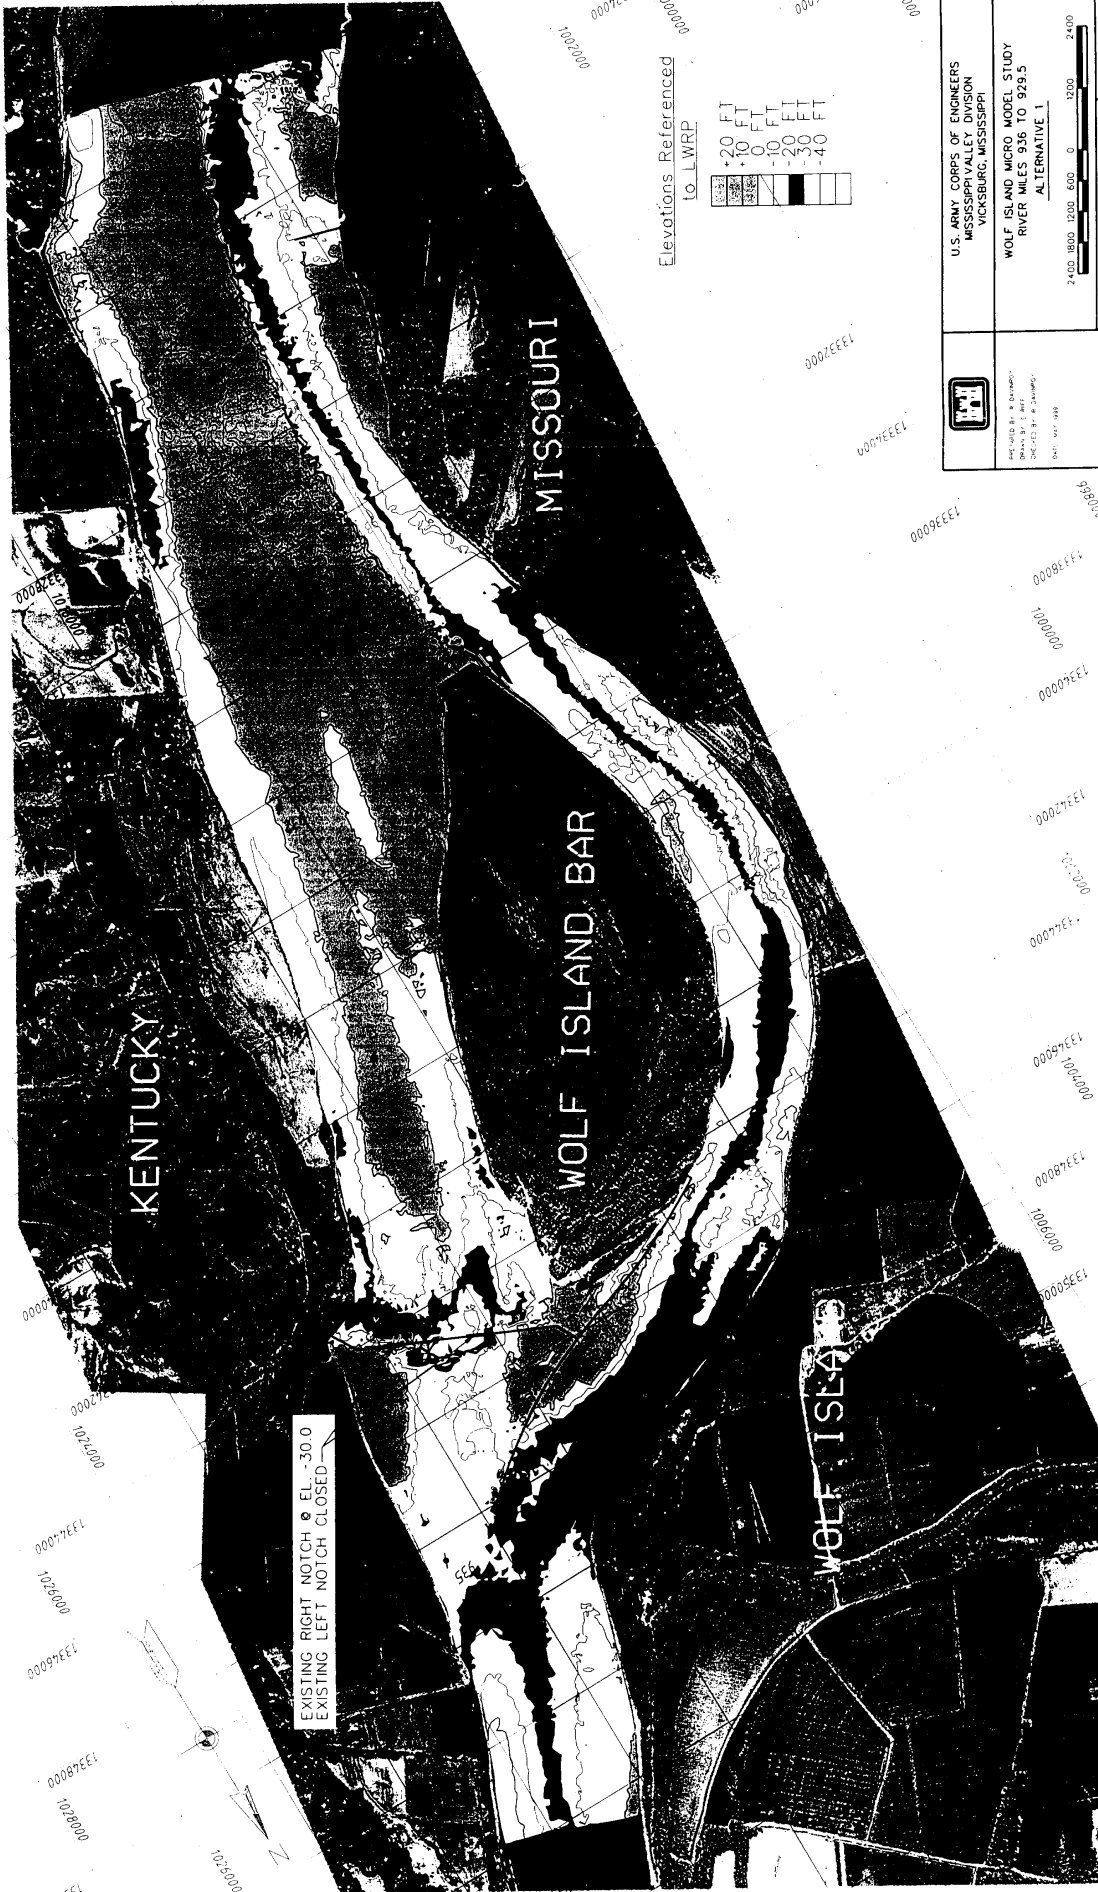
Plate 17 shows the resultant bed configuration of the micro model base test. The base test was developed from the simulation of successive design hydrographs until bed stability was reached and a similar bed response was achieved as compared with the prototype surveys. Results of the base test and comparison to the prototype indicated the following trends:

Entrance conditions of the model began at approximately Mile 937.5. At Mile 936.5, off the left descending bank at Columbus Revetment, the thalweg developed in the model, with depths between -30 feet and -50 feet LWRP. This

scour hole pattern followed the general trend of the prototype surveys, although in the prototype the scour hole extended approximately 0.5 miles further downstream to Mile 935.8. Between Mile 935.8 and 934.2, a crossing developed in the model, with depths between -10 feet and -20 feet LWRP. Between Mile 935.8 and Mile 935.5, the shallowest area of the crossing developed, with depths near -10 feet LWRP. This same shoaling trend was evident in the prototype surveys.

From Mile 935 to 932, the thalweg developed against the right descending bank. Depths through this segment of the model ranged between -20 feet and -60 feet LWRP. Depths in the prototype were generally less, between -20 feet and -30 feet LWRP. Between Mile 932 and 931, a crossing developed in both the model and the prototype. Depths in the model were slightly shallower than the prototype. Between Mile 932 and the exit conditions of the model, the channel was located against the left descending bank, with depths in both the model and the prototype between -30 feet to -40 feet LWRP.

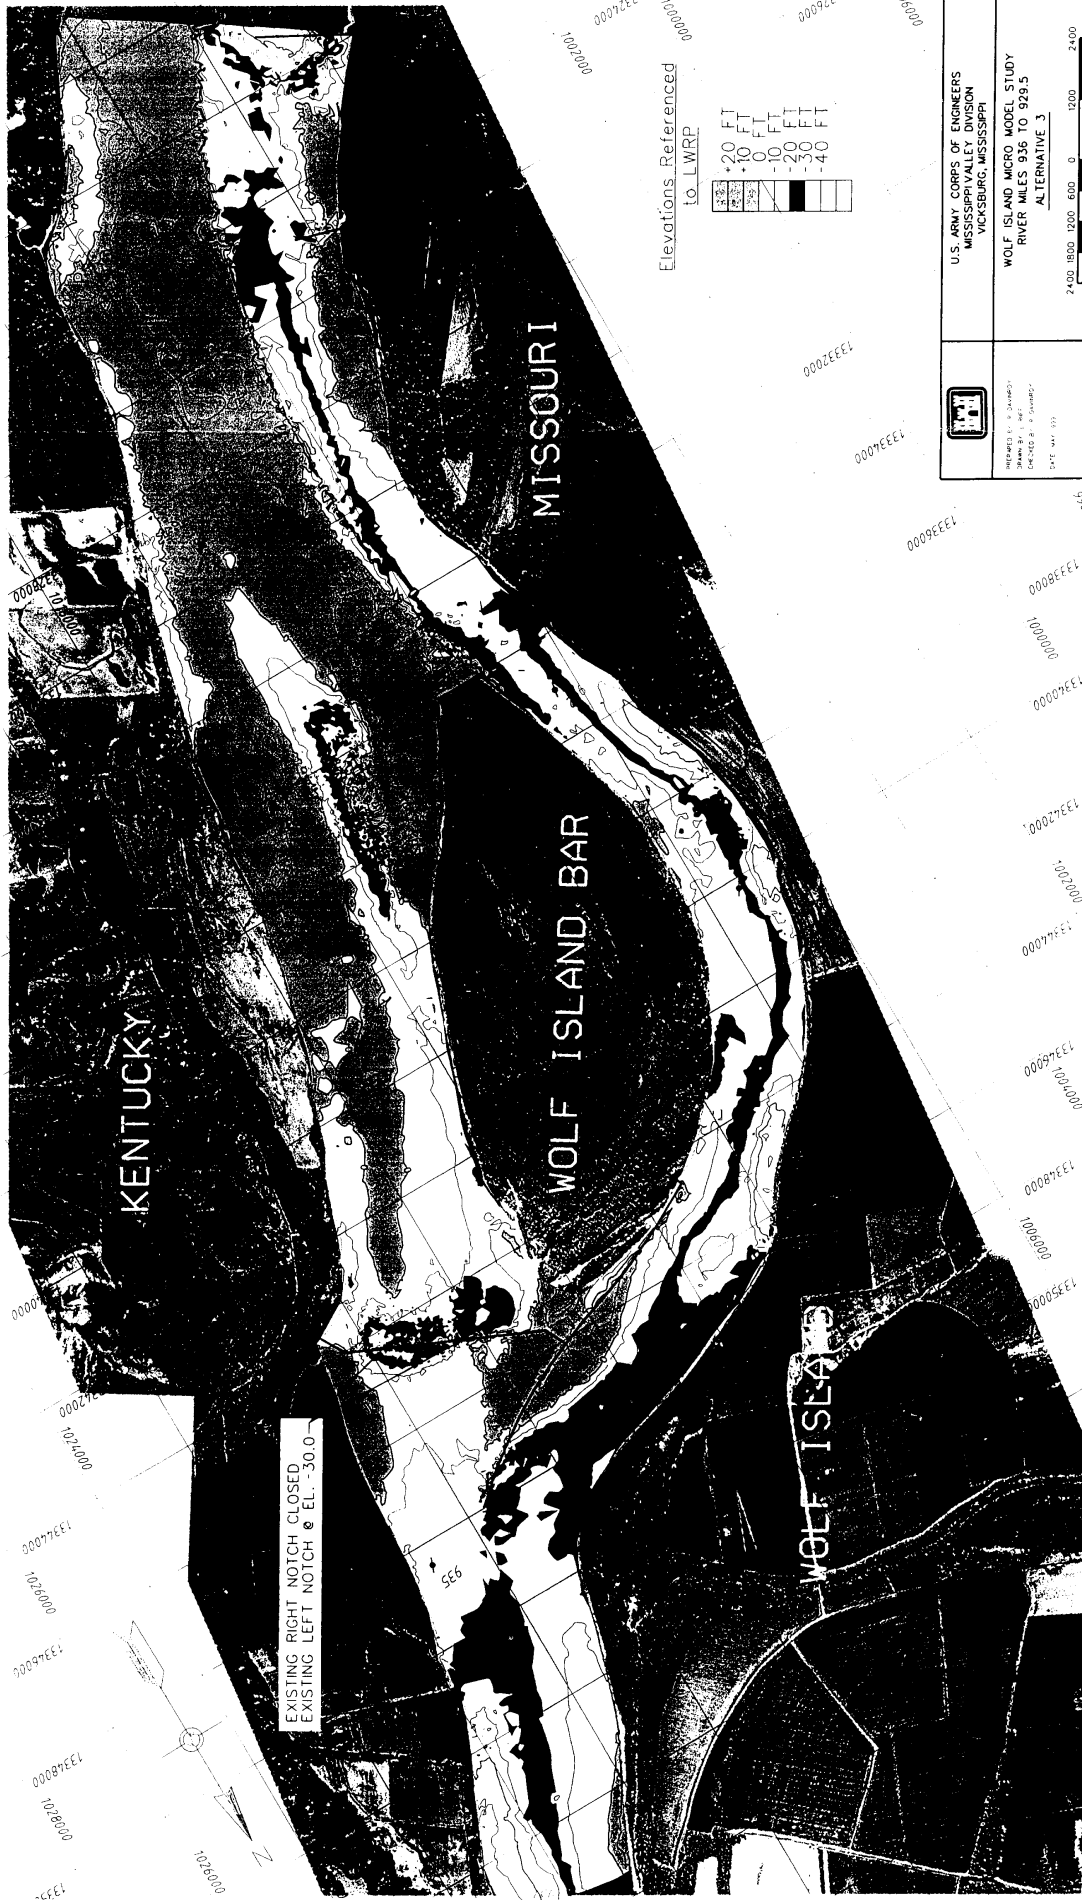
U.S. ARMY CORPS OF ENGINEERS MISSISSIPPI VALLEY DIVISION VICKSBURG, MISSISSIPPI
	WOLF ISLAND MICRO MODEL STUDY RIVER MILES 936 TO 939.5 ALTERNATIVE 3
2400 1800 1200 600 0 1200 2400 HORIZONTAL SCALE: 1" = 1000' 0.00 VERTICAL SCALE: 1" = 20' 0.00	
SHEET NO. 20 OF 20

Within the side channel, scour developed directly below the left notch, with depths near -30 feet LWRP. More flow and sediment were observed moving through the notch as compared to the base test. Between Miles 933 and 931.5, the channel along the left descending bank filled with sediment as a result of this increased load, to depths between 0 and +10 feet LWRP. Once the high bar formed, along the left descending bank, more flow was then forced against the right descending high bar, and a large scour hole developed near Mile 932. A new channel was thus formed, with depths between -20 feet and -30 feet LWRP.

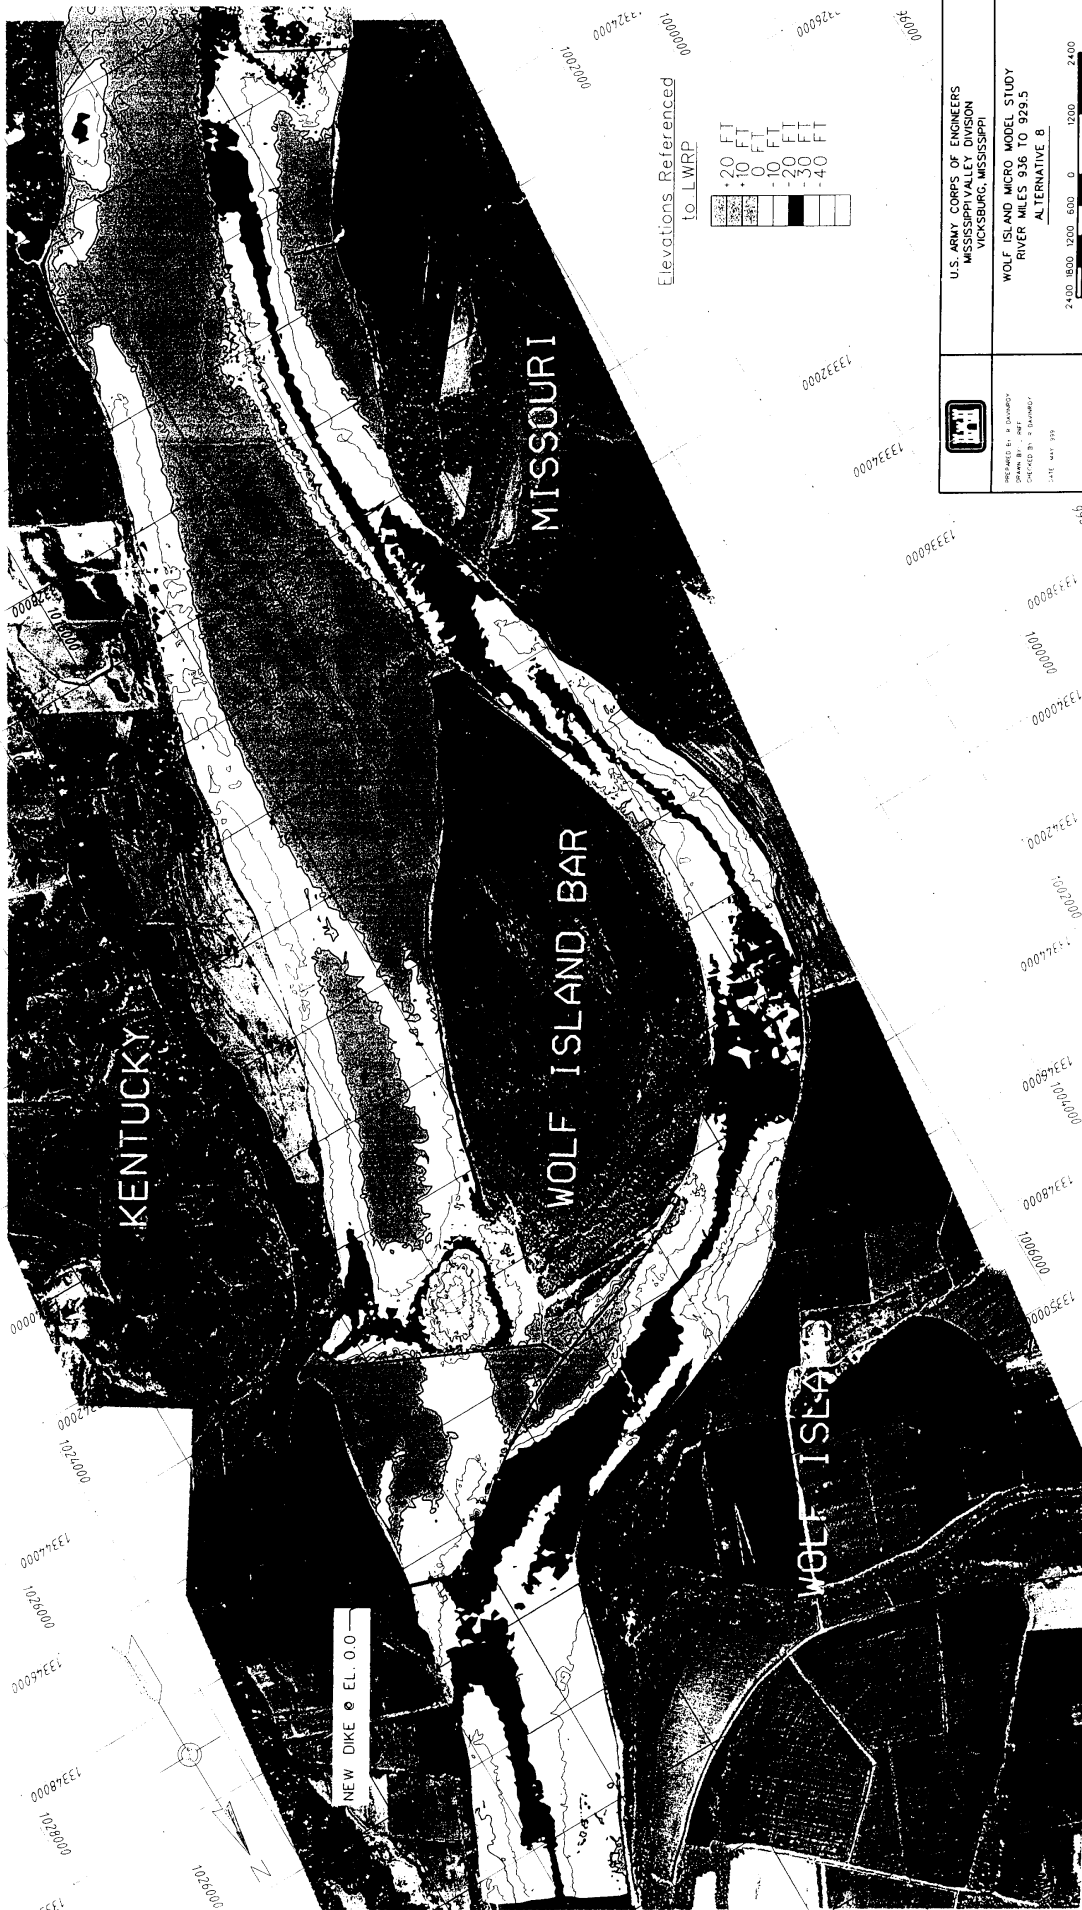
- Alternative 8 showed that placement of a new dike at 0 LWRP at the entrance to the side channel made some minor improvement to the navigation channel directly downstream of the dike. However, shallow depths were still observed in the middle of the crossing, between Miles 936 and

935.5. In addition, the location of this dike, which extended out into the existing navigation channel, posed a possible safety hazard to downbound tows navigating through this reach.
